Coup

FARM PLAN

MARTIN AND WENDY COUP
80 PARAKOKO ROAD
ARIA

2016

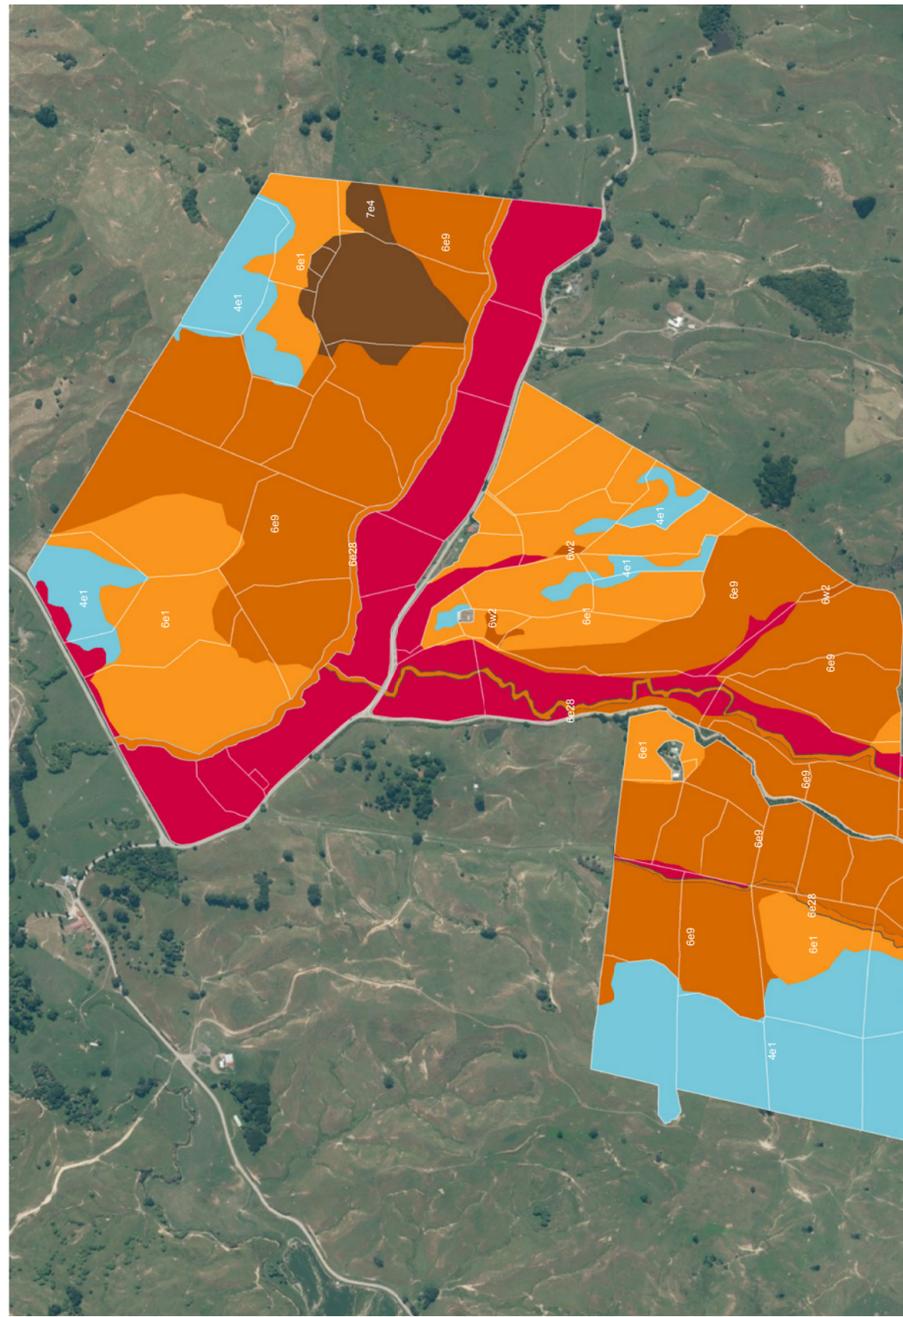
LAND USE CAPABILITY MAP
Upper Farm
Coup Farm
80 Parakoko Road
Aita

The LUC system uses 3 components when classifying land. To illustrate this we can use LUC unit **4w2** as an example. The first numeral **4** is the land class (from 1-8: flat productive to steep non-productive); the second letter **w** indicates the land unit's major limitation from a subclass of four limitations: wetness (w), erosion (e), soil (s) and climate (c); and the final numeral **2** provides a regional land unit classification.

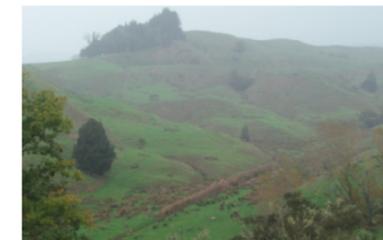
6e9 ■

Strongly rolling to moderately steep slopes on tertiary lithologies with a moderate potential for earthflow and gully erosion.

Actual: Slight to moderate earthflow erosion. Nil to slight gully, soil slip and sheet erosion.

Potential: Moderate earthflow and gully erosion. Slight soil slip and sheet erosion.

- > Potential for moderate earthflow and gully erosion. Slight soil slip and sheet erosion.
- > Soils are prone to pugging and treading damage when wet.

- > Pastoral production with conservation measures, plantings.

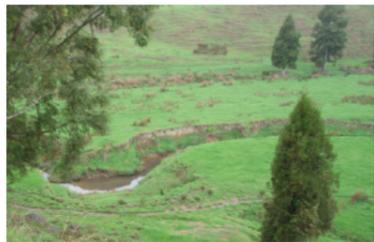
6e28

Strongly rolling to steep banks found adjacent to stream and rivers.

Actual: Nil to moderate streambank erosion.

Potential: Severe streambank erosion.

> Prone to severe streambank erosion.

> Weakly developed soils, prone to treading damage from cattle.

> Exclude cattle.

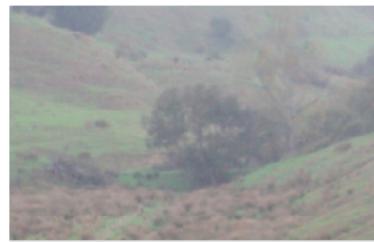
6w2

Flat to undulating swamps which have a continuing wetness limitation when drained.

Actual: Slight sediment deposition.

Potential: Moderate deposition and slight streambank erosion.

> High water table.

> Susceptible to treading damage from cattle when waterlogged.

> Wetland

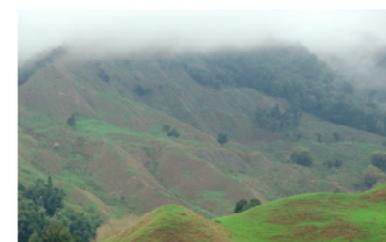
7e4

Strongly rolling to steep very broken slopes on sedimentary lithologies with a severe earthflow and slump potential.

Actual: Slight to severe earthflow and slump erosion. Slight to moderate gully erosion. Negligible to slight soil slip and sheet erosion.

Potential: Severe earthflow and slump erosion. Moderate gully erosion, soil slip and sheet erosion.

> Potential for severe earthflow and slump erosion. Moderate gully erosion, soil slip and sheet erosion.

> Pastoral production with intensive conservation measures, intensive poplar plantings and dewatering.

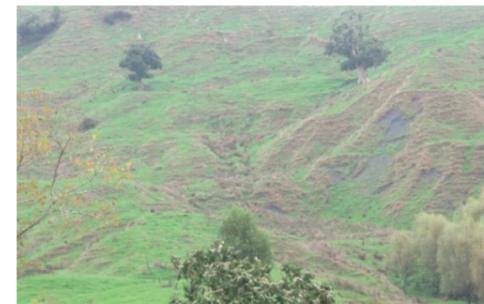
The moderate to steep hill country on the property with only slight to moderate earthflow and soil slip erosion can be controlled with space planted trees at 12 to 15 metre spacings up ephemeral waterways and over the erosion prone parts of the slope (see the orange space/gully plantings icons on the Recommended Treatments Map).

Start by planting up from the bottom of the slope or gully, working up the wetter ephemeral waterways.

A total of 300 poles are required for stabilising the gully systems and steeper slopes on the property (see orange space/gully plantings icons on the Recommended Treatments Map).

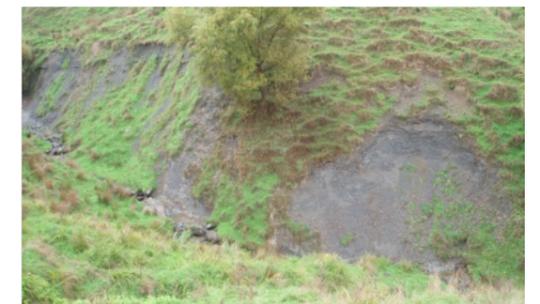
GULLY EROSION

Gully erosion is the removal of soil or soft rock material by water, forming distinct narrow channels, which usually carry water during and immediately after rains.

Where there is adequate soil depth, the gully erosion can be controlled by pair planting poplar and willow poles at 10-12 metre intervals in the gully system in order to slow the flow of the water.

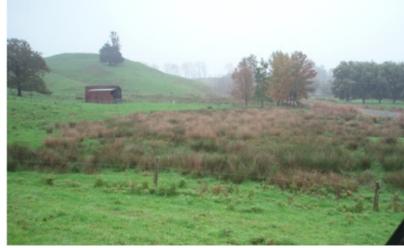
The soils of LUC unit 3w1 found in the narrow gullies are formed from fine textured alluvium.

These soils are weakly developed and are prone to pugging and treading damage from heavy cattle when wet. Care is needed when farming these soils to minimise the risk of treading damage during wetter periods. A significant pugging event can drastically reduce pasture productivity.

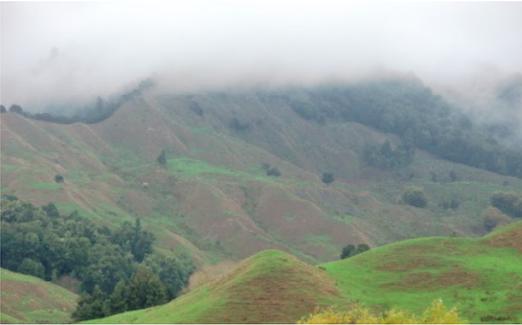
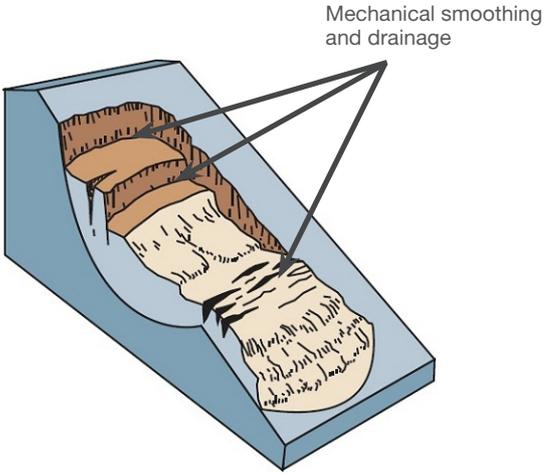
AREA 1A & 1B
EARTHFLOW/SLUMP STABILISATION

There is moderate and severe earthflow and slump erosion occurring across Area 1a and 1b as part of the more extensive earthflow/slump complex situated at the back of the property. Area 1a has a Paraheka Stream tributary situated at the bottom of the slope which is also currently undermining slope stability and is contributing to the malformation of this area.

A practical way to stabilise these areas requires a combination of mechanical smoothing, dewatering and intensive space planting of willows or poplars. Allow continued scrub reversion along the stream banks, up gullies or where soils are too skeletal for poplar/willow pole establishment.

Where possible, tension cracks or areas of pooled water (especially below the head scarps) should be smoothed and drained as it is critical to prevent water pooling and lubricating the slip or tension planes. Any natural or manmade dams in these areas should also be drained.

Targeted intensive space planting (350 poles) should be undertaken along the toe of the slope (adjacent to the stream) below the head scarps

and up the wetter ephemeral drainage channels at 10m spacings or where soil depth permits.

Intensive pole planting has been undertaken on Area 1b; mechanical smoothing and dewatering is recommended.

Due to the location, restricted access and the amount of poles required for Area 1a and 2a, a pole drop by helicopter is recommended.

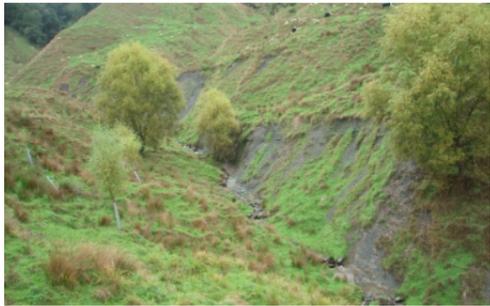
AREA 2
GULLY STABILISATION

Area 2 has moderate and severe gully erosion present. Water has eroded distinct narrow channels that continue to undermine slope stability.

Where there is no vegetation and adequate soil depth, the gully erosion can be controlled by planting poplar or willow poles at 5-10 metre intervals in the gully system (62 either side, totalling 125). Where soil is too skeletal for willow pole survival allow natural re-vegetation.

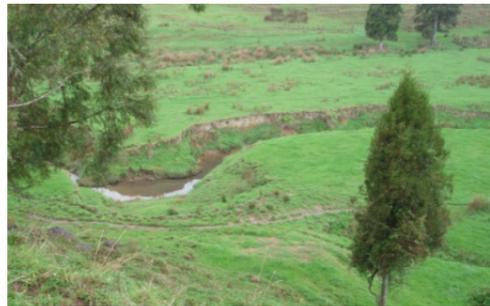
AREA 3A-3G
RIPARIAN RETIREMENT

Area 3a-3g consists of 10.4 ha of unfenced eroding river and stream riparian margins.

To enhance the stability of the river/stream banks and improve water quality, stock should be excluded from these riparian areas with 10.6 km of fencing and the further planting of 125 shrub willows along river and stream pressure points (see Recommended Treatments Map for locations).

These riparian margins can be grazed for weed control purposes with sheep.

Area	Fencing (metres)
3a	7300
3b	1190
3c	450
3d	380
3e	220
3f	340
3g	720
Total	10600

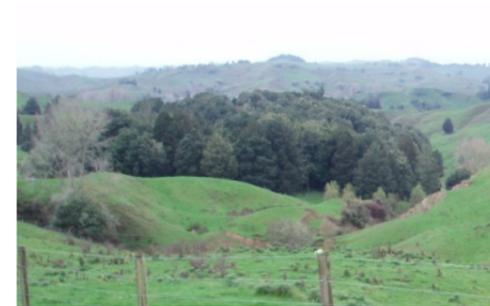
AREA 4A & 4B
BUSH RETIREMENT

Area 4a (4.1 ha) and 4b (1.4 ha) consists of maturing indigenous bush that provides slope stabilisation and biodiversity values. These areas should be left to fully regenerate and retired from the pastoral system with 610m (Area 4a: 340m, Area 4b: 270m) of stock proof fencing.

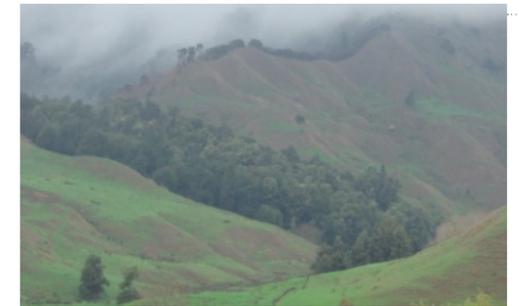
AREA 5
REGENERATION

Area 5 (5.9 ha) consists of small areas of bush and scrub located on steep erosion prone slopes. These areas are generally impractical to fence off from stock but provide slope stability for LUC Class 6 and 7 land. These areas should not be cleared but allowed to regenerate providing a cheap form of soil conservation.
